## **Georgian College – Load Management**

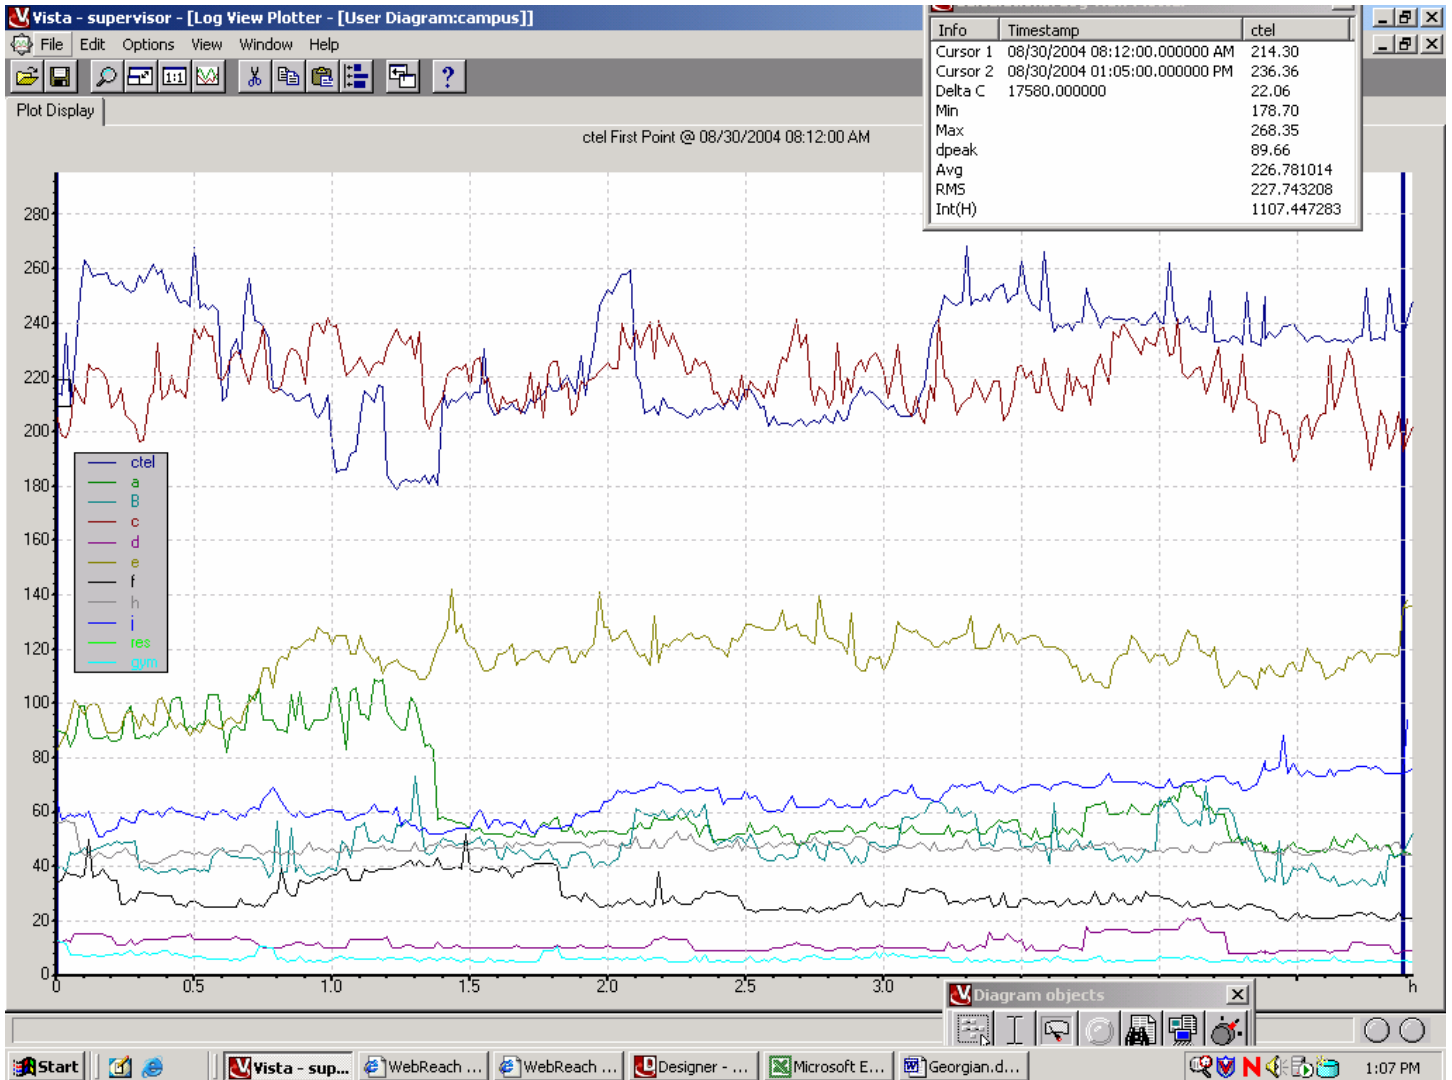
ION Enterprise Vista screen allows operators at Georgian College to track all loads across campus to ensure the transformer is not over-loaded.

Using the power monitoring system, each building was flagged at a specified consumption level to be able to identify which building was the cause in the case of an overall rise in kW usage. If consumption rose above the flagged level, the entire building would simply be shut down. "The 2 MVA transformer was the only one I had left. I wasn't about to risk having it go down," said Choma. By establishing load trends for each building, they were able to predict load fluctuations and prevent buildings from exceeding their allotted kilowatts. They spent four days closely monitoring the whole campus, shedding loads when required and manually disconnecting pop machines, computer labs, hand-dryers, anything non-essential that could be taken off-line. "The in-house staff switched the loads that could not be changed remotely from the central control room, without their efforts we would not have accomplished what we did," said Ron Howden of Langford & Associates who spent several days in the control room monitoring the fluctuating loads. The student residence had been put on diesel generation on the first day after the failure since students had already begun arriving and there was too much possibility for demand overrun.
